**Technical Data Sheet**

Bridge Identification:	1771110000000B03
Facility Carried:	I-94
Feature Intersected:	Black River
Location:	Port Huron Township
County:	St. Clair
Region:	Metro
Year Built:	1950
Year Reconstructed:	1975, 1982
Bridge Type:	Two-Girder System
No. of Spans:	10
Deck Area:	24,450 S.F.
Paint System:	Red Lead (Joints Type 4)
Paint Area:	112,000 S.F.

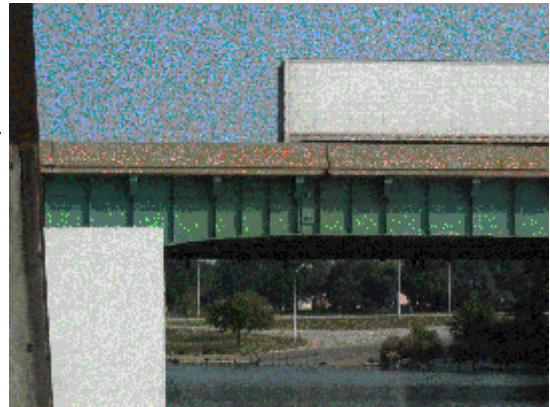
Pin and Hanger Assembly (3)

- ! Pin and hanger assemblies.** (Photo 3)
- ! Tension areas of main girders.** See Figure 1 in the Inspection and Maintenance Program section of this manual for tension areas of main girders.
- ! Floorbeam-to-girder connections.**
- ! Lateral bracing-to-girder connections.**
- ! Tack welds on gusset plates in various locations.**

<b>Recommendation</b>	<b>Schedule</b>
Clean bridge drainage system components (deck drains and downspouts).	6 to 12 months
Flush bridge deck joints and check for leaks.	12 months
Powerwash bridge superstructure.	12 months
Powerwash bearings and pin and hanger assemblies.	12 months
